INSPECTION REPORT

INSPECTED BY  
Jaime Contreras  
Valor Inspection  
Services

INSPECTION DATE  
📅 1/11/2024  
🕒 03:00 PM

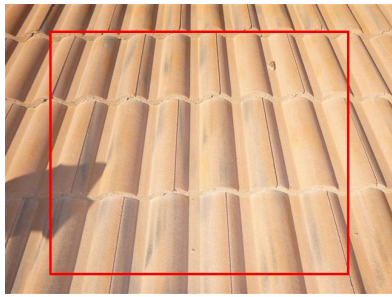
1.0 Item 1 (Picture)

(1) Inspector noted roof covering is weathered/worn in one or more locations. While it appears to have remaining life, some areas may need patching/repair over time. No major defects noted at time of inspection. For a more comprehensive analysis of remaining economic life of roof, review with licensed

roofing contractor. Review/repair as needed.

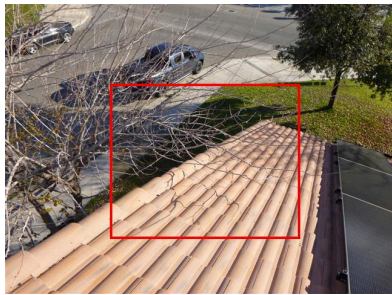
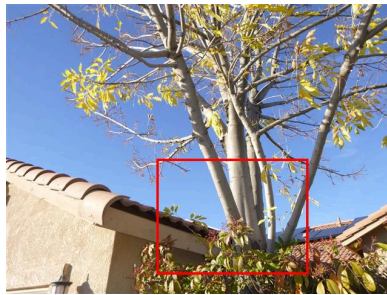
1.0 Item 2 (Picture)

(2) Inspector recommends tree limbs that are in contact with roof, or hanging near, should be trimmed away. Review/maintenance recommended.

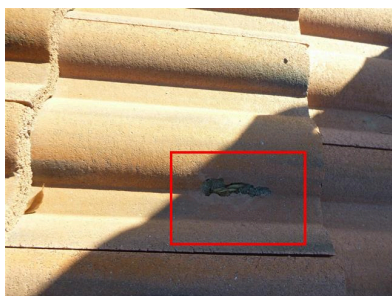
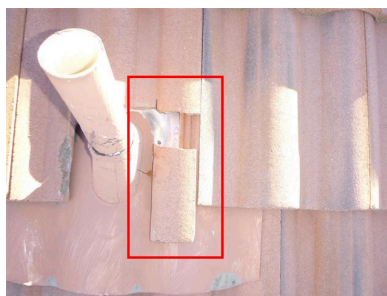
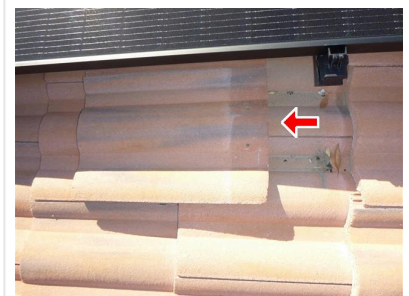
1.0 Item 4 (Picture)

(3) Inspector noted cracked/damaged and/or slipped tiles at one or more locations. Pictures shown as a few examples. Review/repair by a licensed roofing contractor or qualified professional recommended.

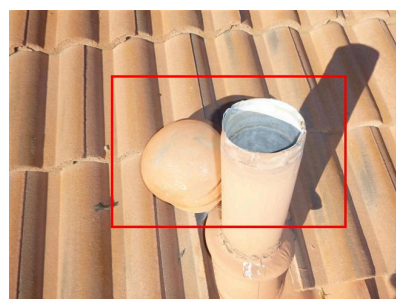
1.2 Item 1 (Picture)

Inspector noted roof ventilation cap damaged at one or more locations. Review repair recommended.

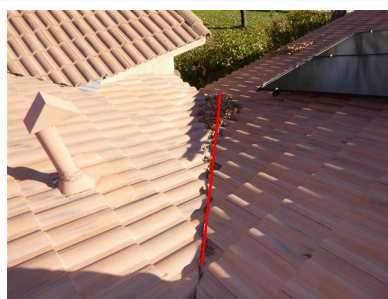
1.3 Item 2 (Picture)

Inspector noted debris on roof in valleys/gutters. This inspector recommends cleaning for adequate drainage and elimination of potential hazards.

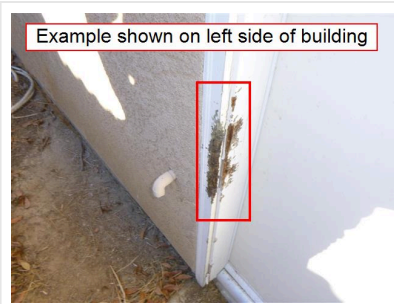
2.2 Item 1 (Picture)

Inspector noted chipped/peeling paint and/or general wear on door casing and trim in one or more locations. This is considered cosmetic and does not appear to affect the functionality of intended use. Review/repair as needed.

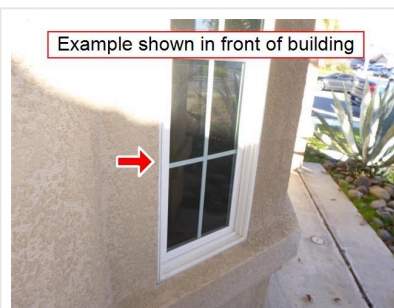
2.3 Item 1 (Picture)

Inspector noted damaged/missing screens at one or more locations. Pictures shown as a few examples. This is considered cosmetic and does not affect the functionality of the unit. Review recommended.

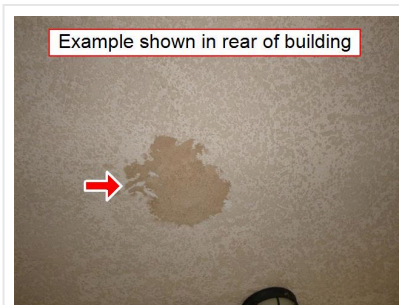
2.8 Item 7 (Picture)

(3) Inspector noted previous repair at one or more locations. Quality of work appears to be done in a manner that is consistent with home's design/appeal. Review recommended.

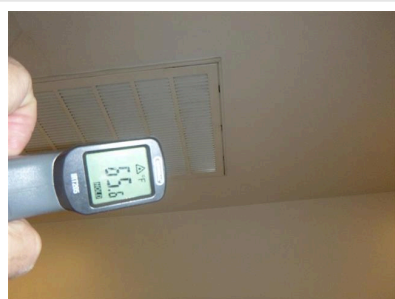
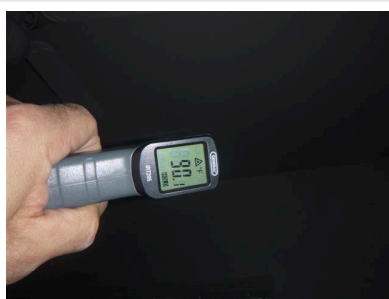
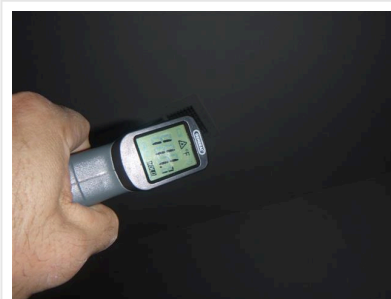
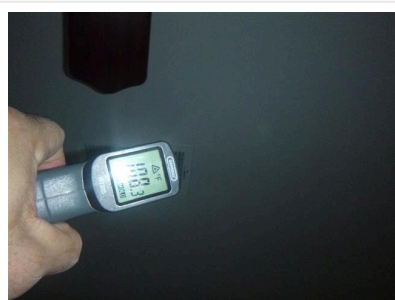
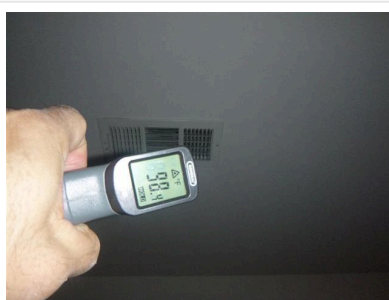
4.1 Item 1 (Picture)

Inspector noted the thermostat and furnace was fully functional at time of inspection and operating well within the appropriate temperature differentials.

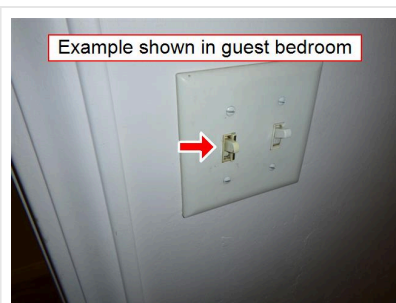
6.4 Item 2 (Picture)

(2) Inspector noted loose connection at switch/receptacle at one or more locations. Review/repair recommended.

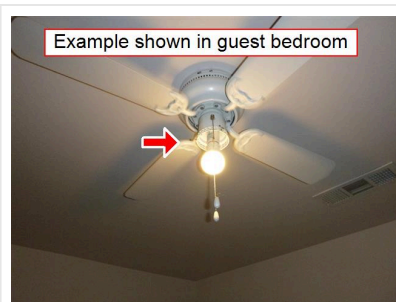
6.4 Item 3 (Picture)

(3) Inspector noted light fixture missing/damaged globe. Review/repair as needed.

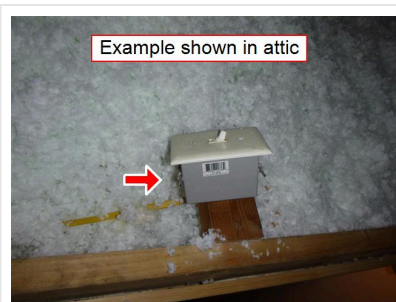
6.4 Item 4 (Picture)

(4) **(MODERATE)** Inspector noted light switch/receptacle not mounted in attic. This could be a safety issue. Review/repair recommended.

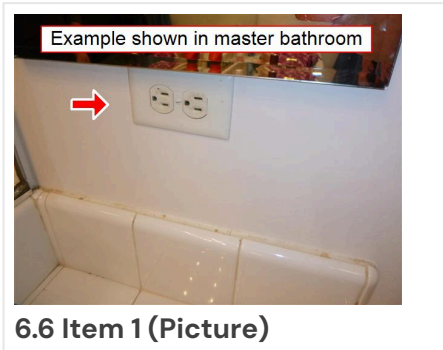
6.6 Item 1 (Picture)

**(MODERATE)** Inspector noted there is no GFCI outlet found in bath. While the outlet may be connected to a GFCI elsewhere in home, inspector recommends a duplex GFCI outlet be installed individually in all bathrooms, kitchen/utility areas and exterior outlets near a water source. Review/repair recommended by licensed residential electrician.

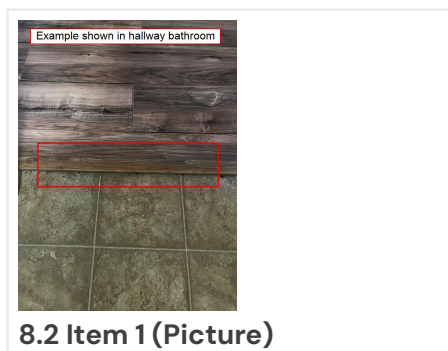
(1) Inspector noted loose transition strip separating adjoining flooring. Review/repair recommended.

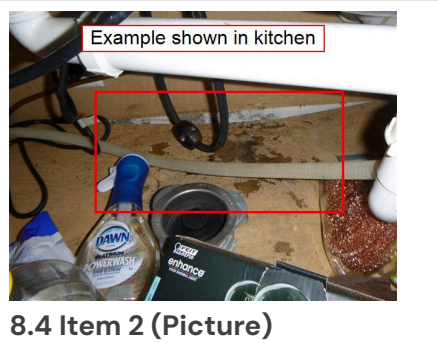
(2) Inspector noted evidence of water staining/damage in one or more locations. Stains appear to be old. No active leaks noted at time of inspection.

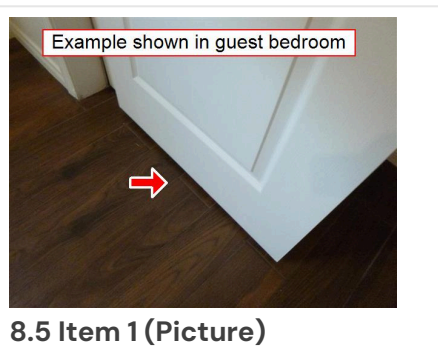
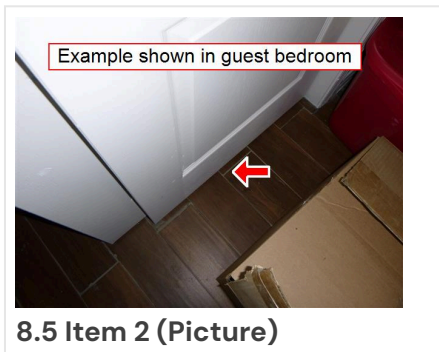
Inspector noted closet door bypass guide missing at one or more locations. Review/repair as needed.

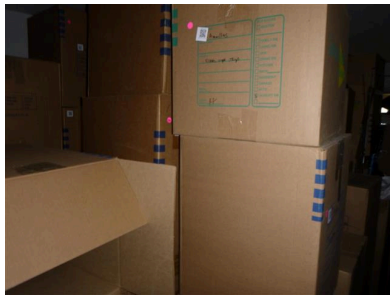
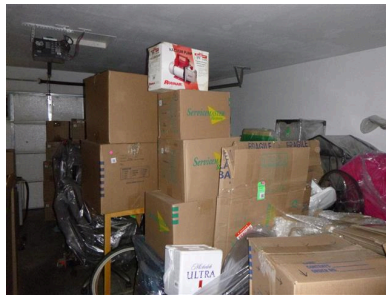
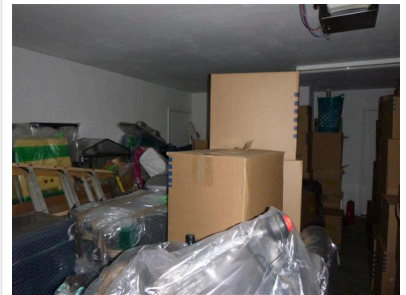
9.1 Item 1 (Picture)

Inspector noted access impaired due to personal belongings. Because of this, certain walls/windows/outlets could not be visually or physically inspected for integrity/functionality.

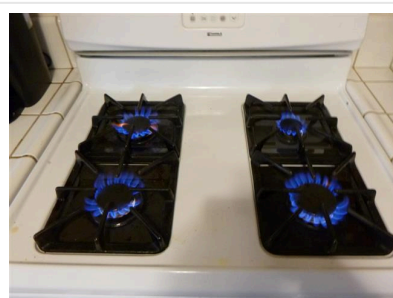
10.1 Item 1 (Picture)

Inspector noted range/oven and cooktop were functional at time of inspection.

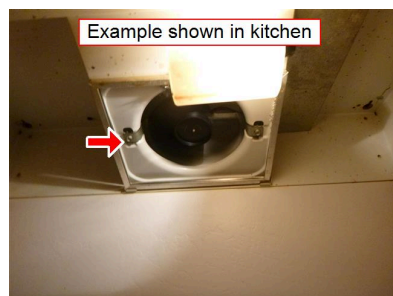
10.2 Item 1 (Picture)

Inspector noted hood/vent was functional at time of inspection but was missing screen at fan. Review/repair recommended.

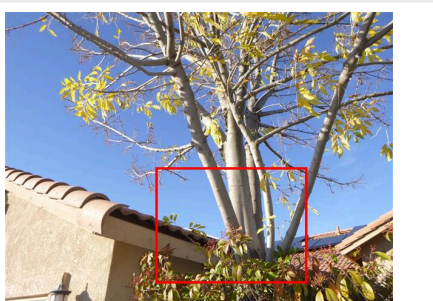
1.0 Item 2 (Picture)

(2) Inspector recommends tree limbs that are in contact with roof, or hanging near, should be trimmed away. Review/maintenance recommended.

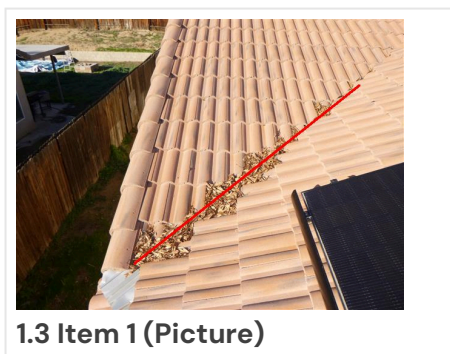
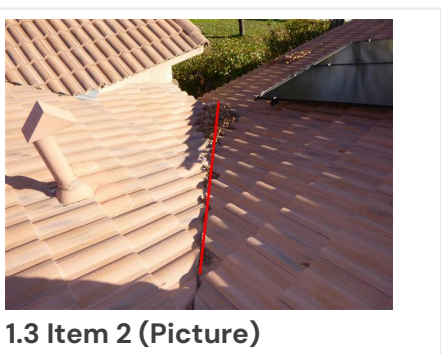
Inspector noted debris on roof in valleys/gutters. This inspector recommends cleaning for adequate drainage and elimination of potential hazards.

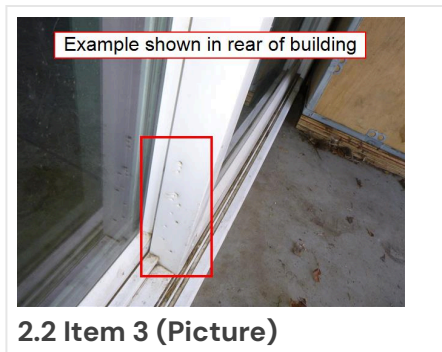
This is considered cosmetic and does not appear to affect the functionality of intended use. Review/repair as needed.

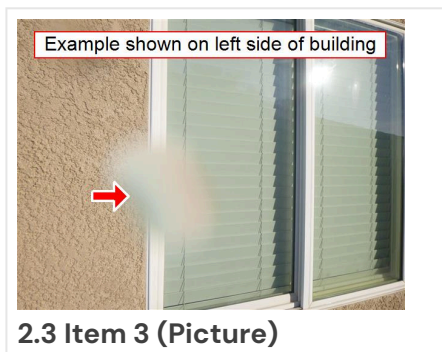
Inspector noted damaged/missing screens at one or more locations. Pictures shown as a few examples. This is considered cosmetic and does not affect the functionality of the unit. Review recommended.

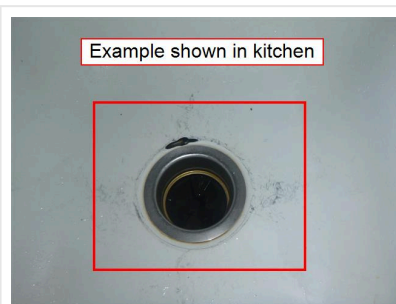
5.1 Item 1 (Picture)

Inspector noted cosmetic damage to sink at one or more locations. Review/repair as needed.

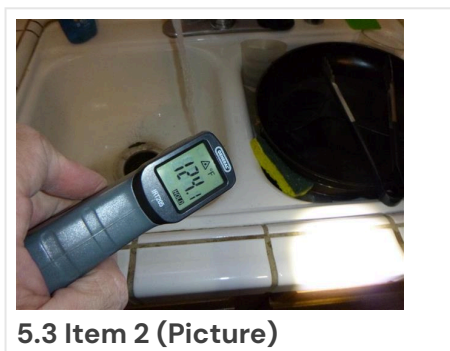
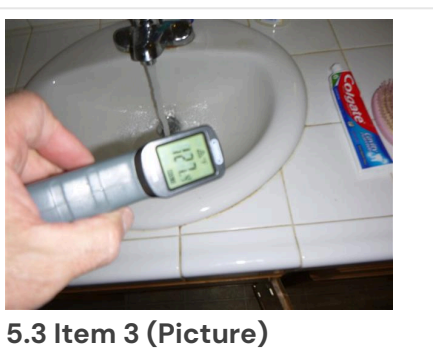
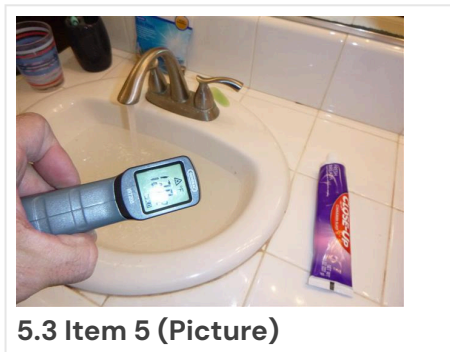
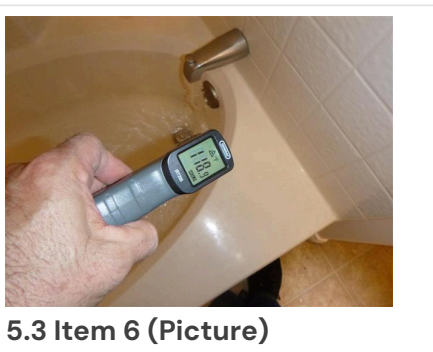
(2) Inspector noted all bathroom sinks/tubs/showers had adequate temperature readings for hot water supplied to systems.

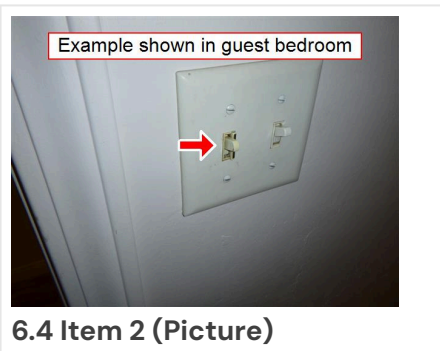
(2) Inspector noted loose connection at switch/receptacle at one or more locations. Review/repair recommended.

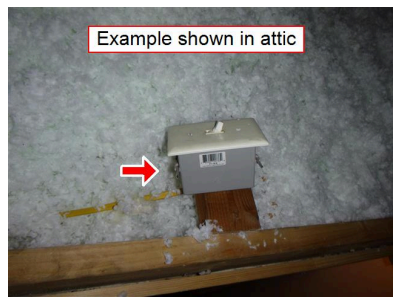
6.4 Item 4 (Picture)

(4) **(MODERATE)** Inspector noted light switch/receptacle not mounted in attic. This could be a safety issue. Review/repair recommended.

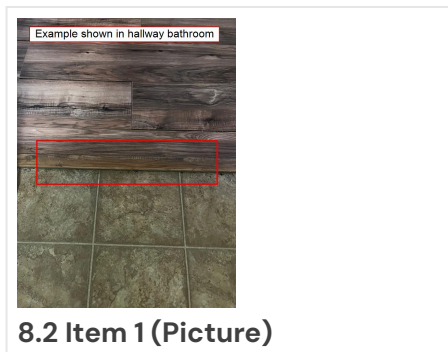
(1) Inspector noted loose transition strip separating adjoining flooring. Review/repair recommended.

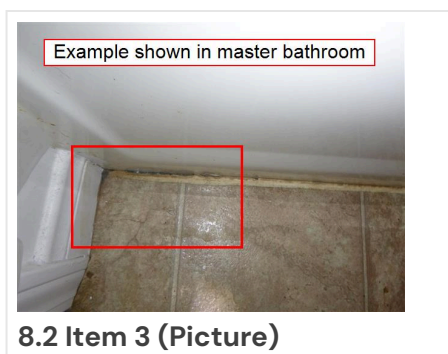
(3) Inspector noted damaged/lifting linoleum in one or more locations. Review/repair as needed.

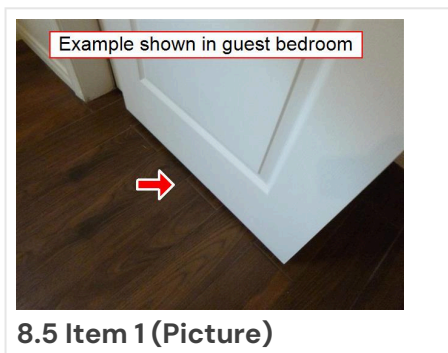
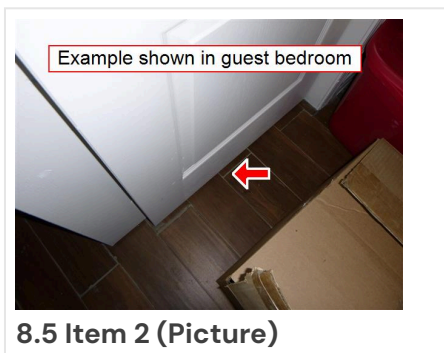
Inspector noted closet door bypass guide missing at one or more locations. Review/repair as needed.

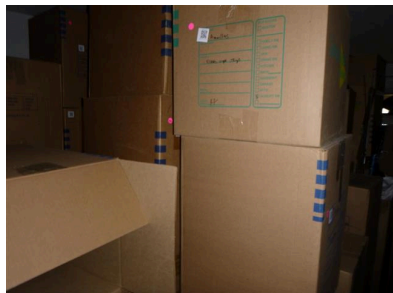
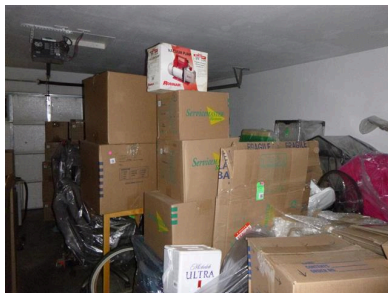
9.1 Item 1 (Picture)

Inspector noted access impaired due to personal belongings. Because of this, certain walls/windows/outlets could not be visually or physically inspected for integrity/functionality.

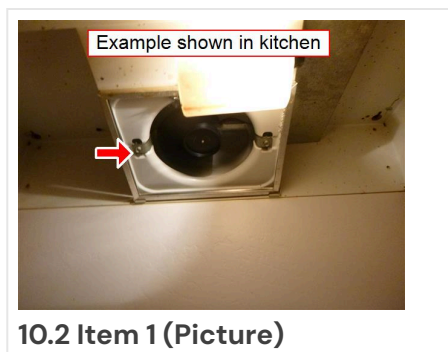
Inspector noted hood/vent was functional at time of inspection but was missing screen at fan. Review/repair recommended.
